The Devon Beaver Project

The story so far...

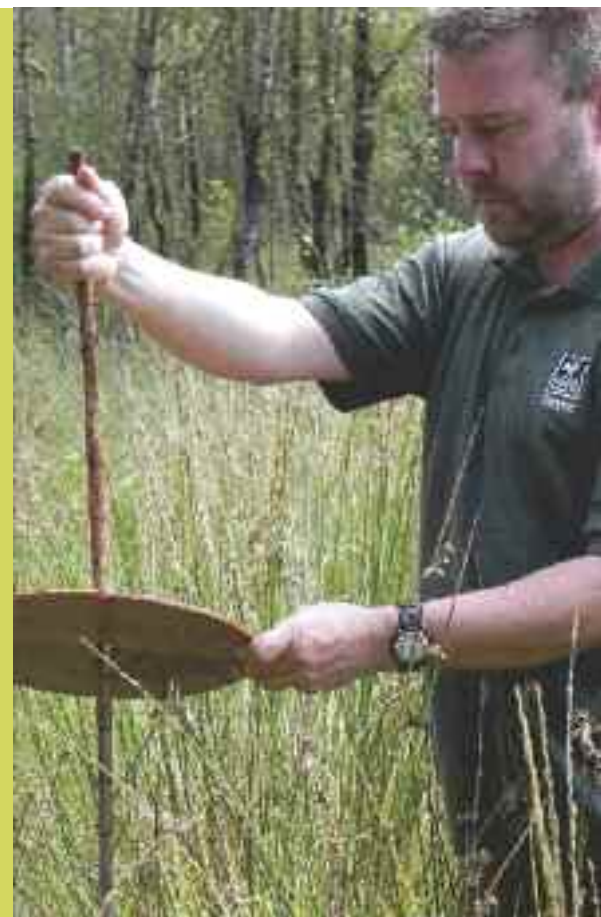
A drop disk is used to measure vegetation height

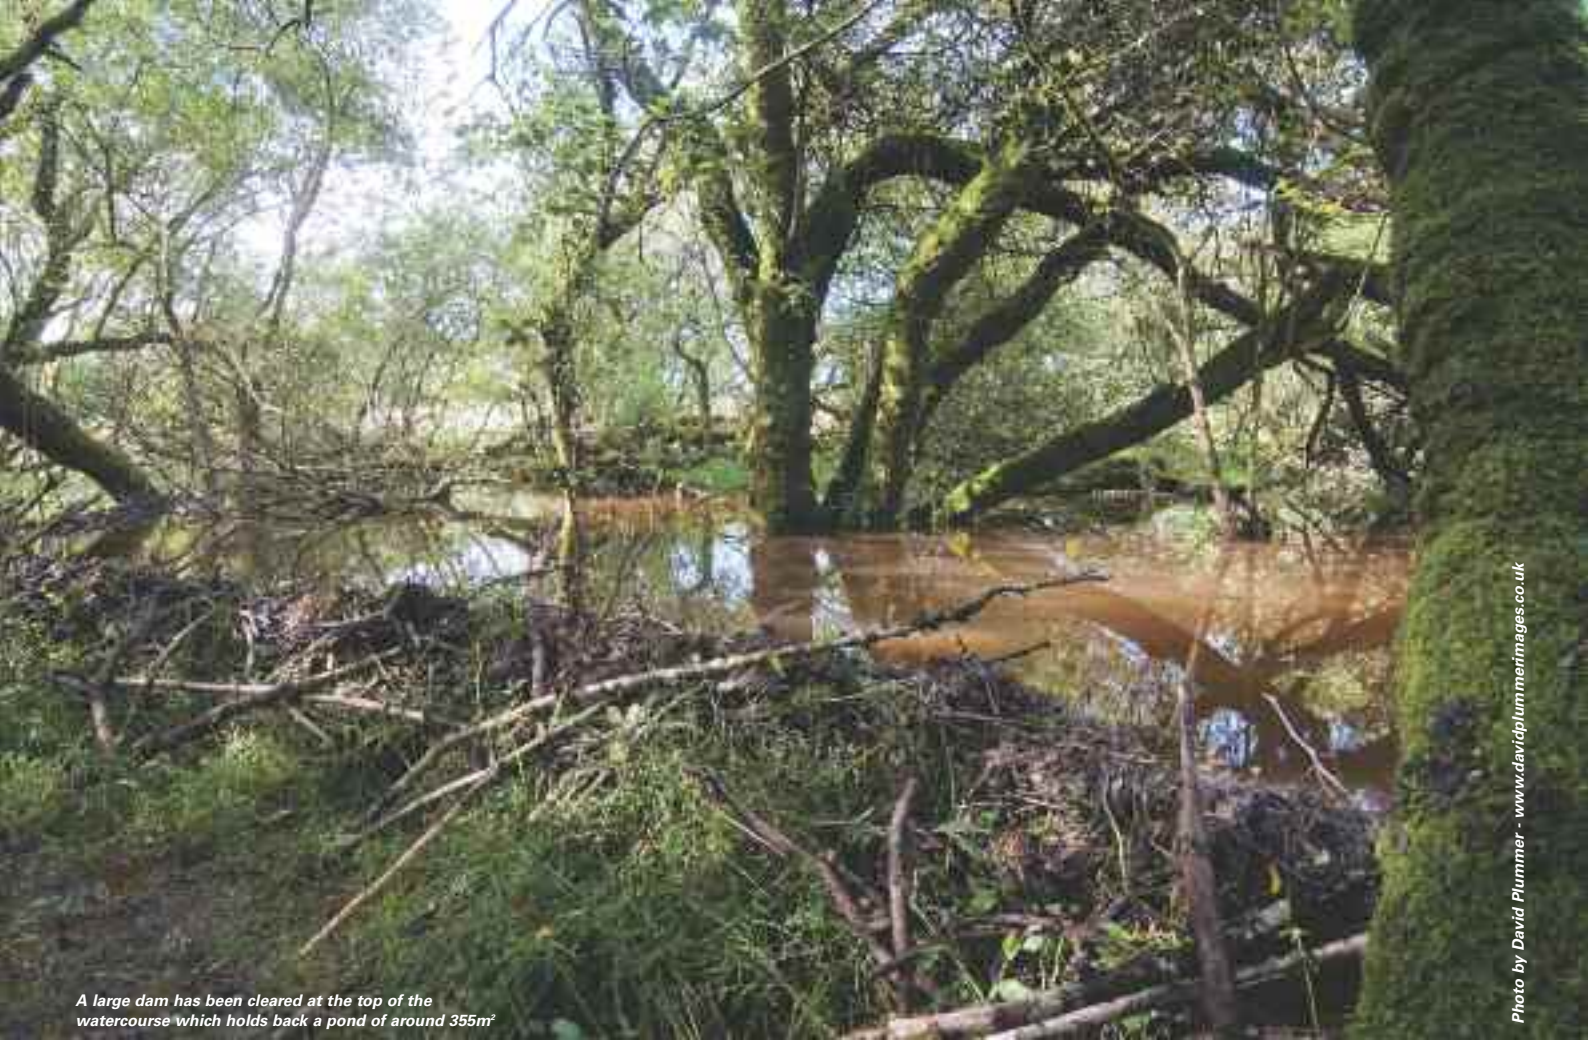
A large dam has been cleared at the top of the watercourse which holds back a pond of around 355m²

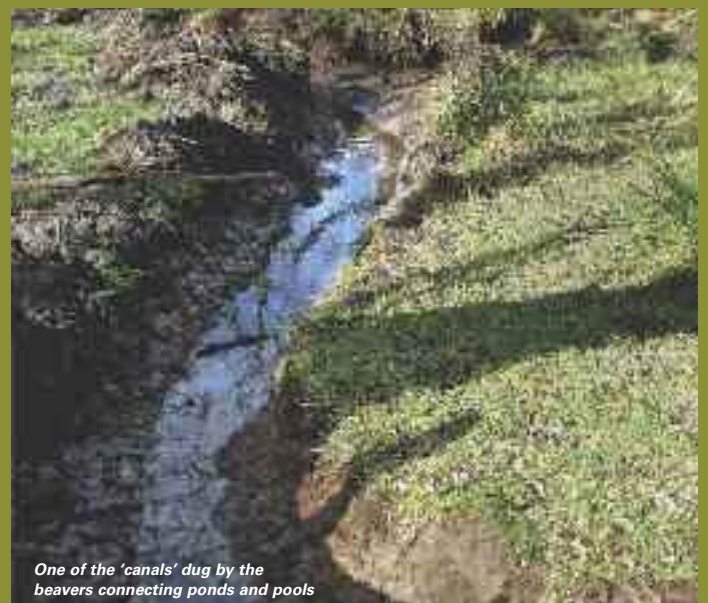
One of the 'canals' dug by the beavers connecting ponds and pools

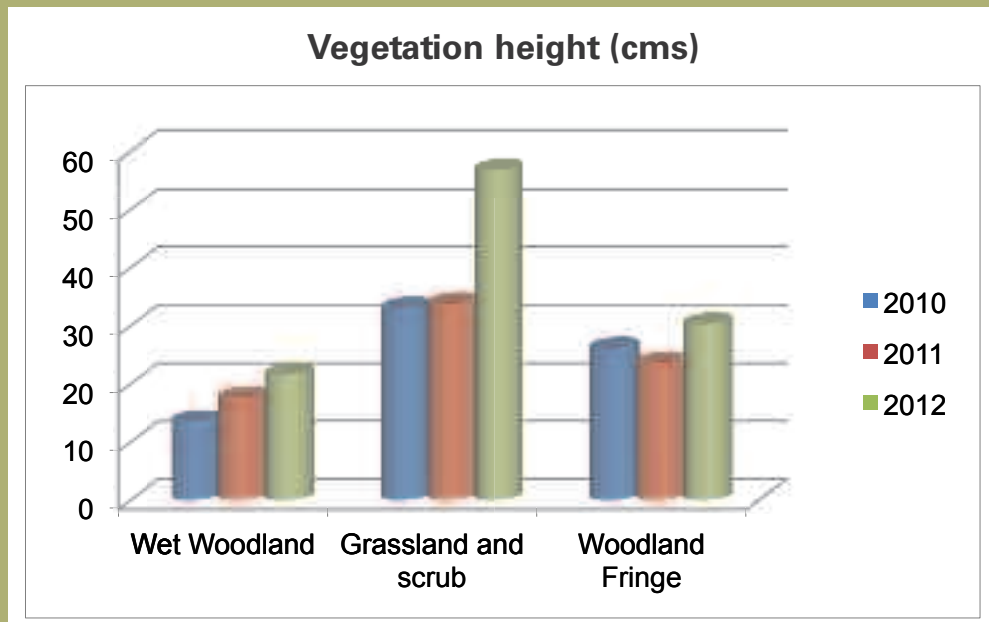
A drop disk is being used to assess changes to the vegetation height. This will tell us how effectively the beavers are changing the dynamic between the grassland and scrub.

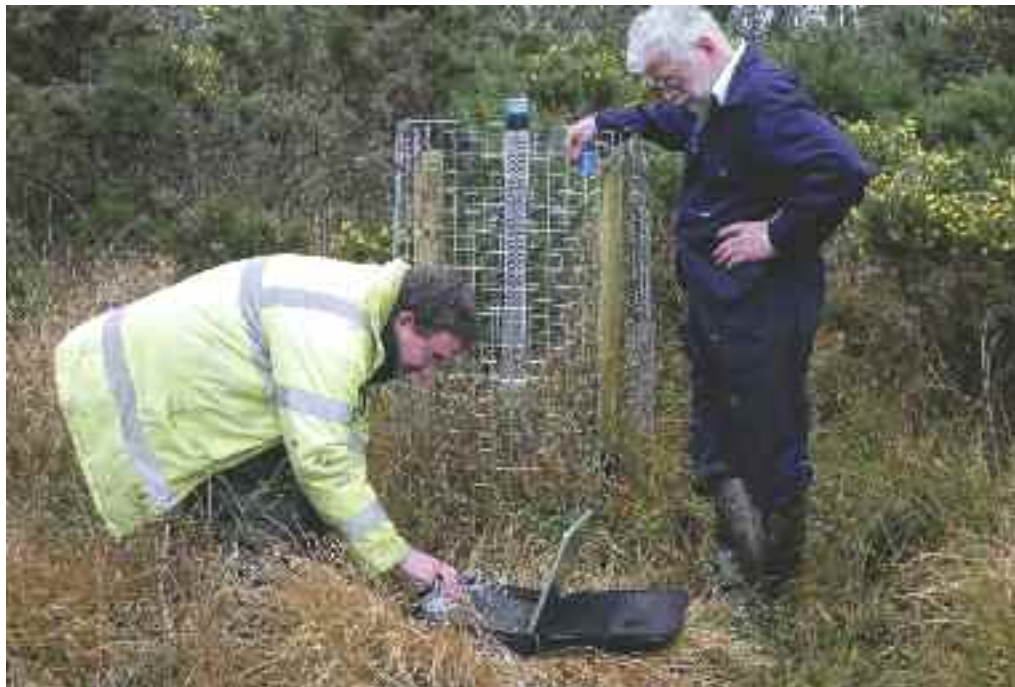
Downloading water level data from the dipwells

A network of eight dipwells were installed in the spring of 2011 to monitor ground water levels in different parts of the site.

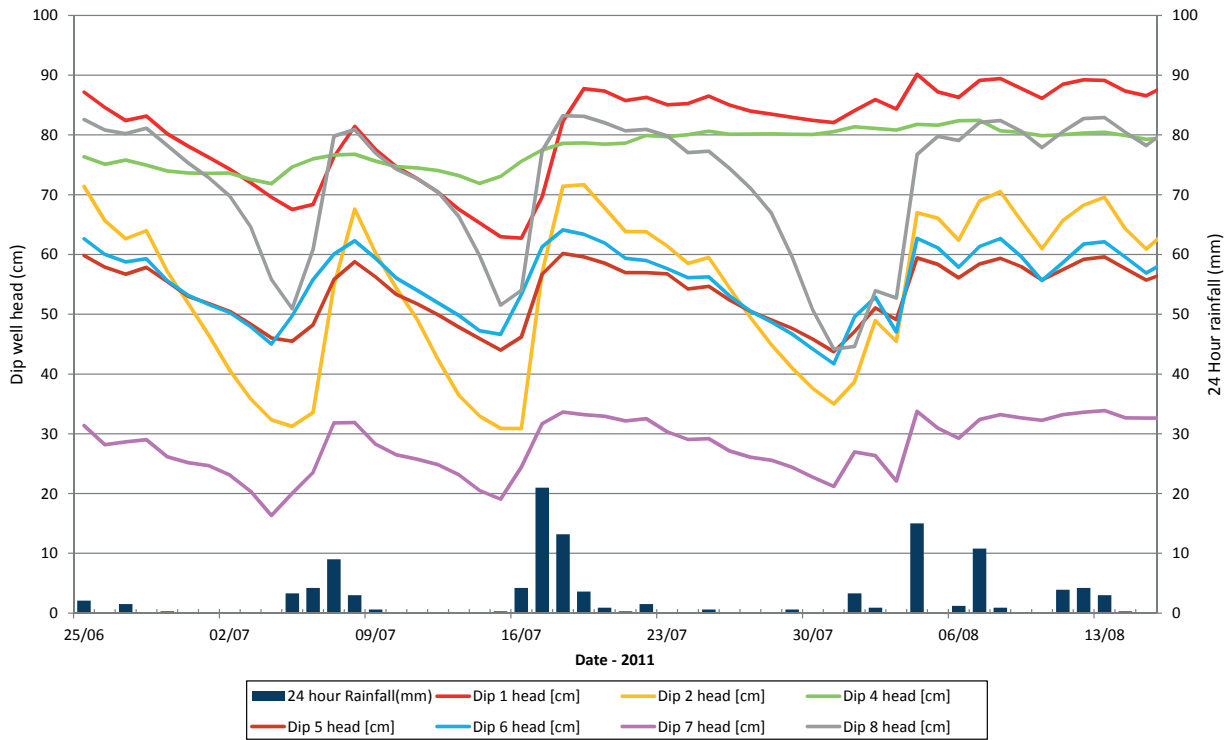
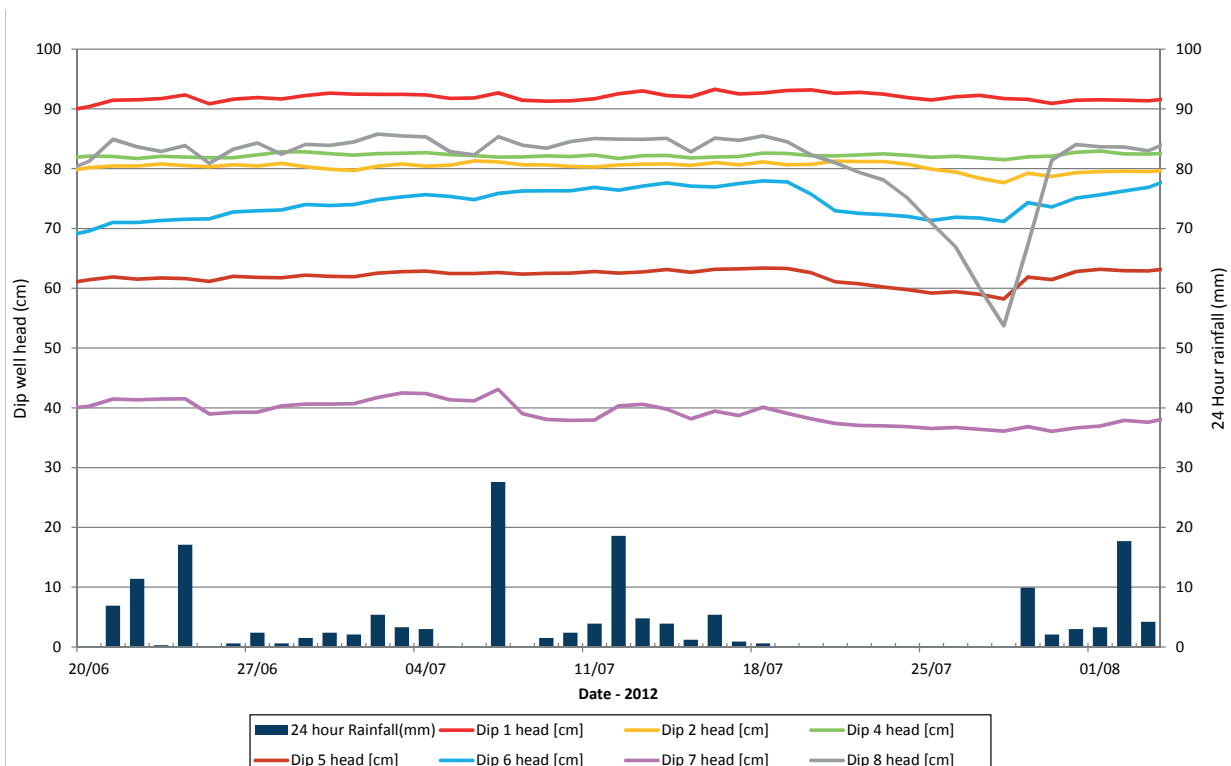
The dipwell data are already revealing changes to groundwater that are occurring. When the graphs of soil water levels in 2011 (above) and 2012 (below) are compared, it appears to show that the levels are fluctuating less, presumably because the beaver dams are holding water back. If this trend could also be shown in the stream, it would strongly indicate that beavers could reduce flood peaks and also increase base flows during droughts.
